## Thermal shock resistance level with mechanical constraints

## Determination of mechanical impact resistance degree (IK tests)

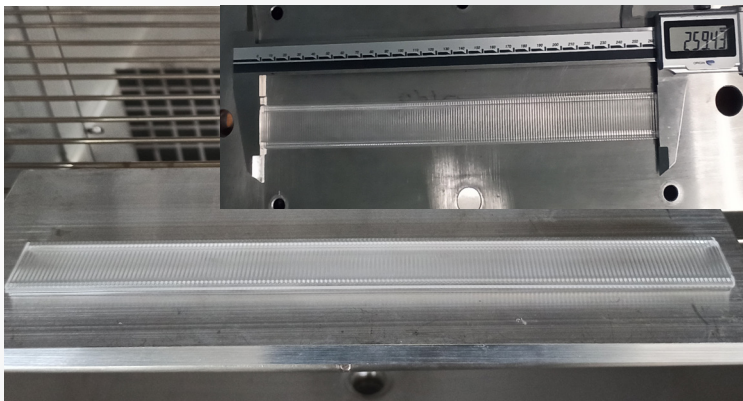
Before starting the tests, a visual inspection was performed in order to check the integrity of the part. The part resulted physically intact. The thermal test was performed at a temperature of 90°C, using the climatic chamber LTH 225°.

Photo: the part in the climatic chamber.

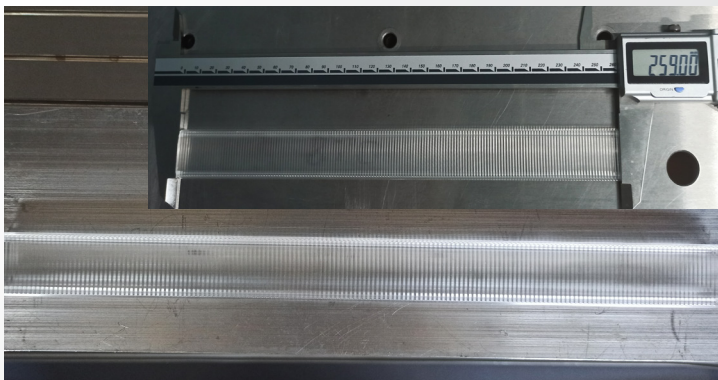
Photo: the part in the climatic chamber after testing.

After testing, a final visual inspection was performed. The result was positive (view photo).

The executed tests show that SAGITTARIO, moulded in PMMA 7N, passed the thermal stress tests without any physical deterioration of the material, up to a temperature of 90°C. At the end of the test the sample size is 259.00 mm.

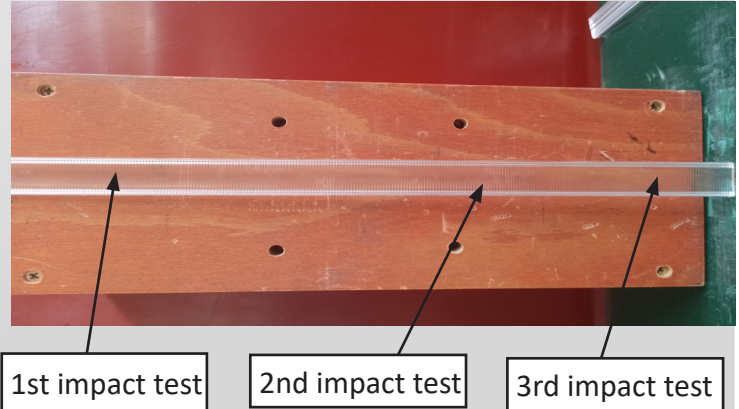
Before starting the tests, a visual inspection was performed in order to check the integrity of the components.

The components resulted physically intact.

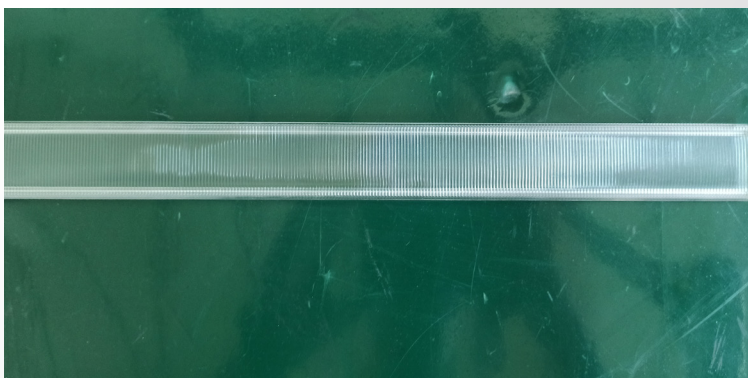
After testing, a final visual inspection was performed. The result was positive (view photo).
