## IP X5 Test

Based on the water penetration resistance test, KFLEX64IP serie proved to be fit for purpose.

## Thermal shock resistance level with mechanical constraints

## Determination of mechanical impact resistance degree (IK tests)

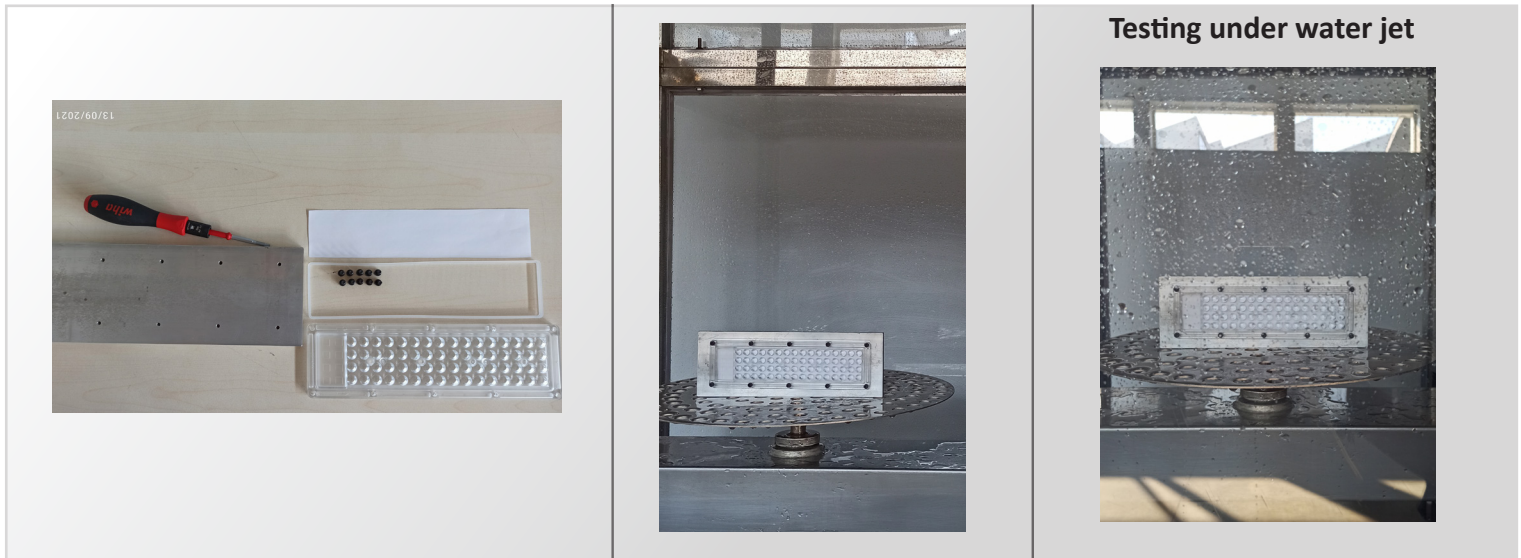
The sample has been subjected to the water-penetration resistance test as follows:

Assembly of the components to test:	Positioning of the assembled sample under the device of watering with:	Water flow:	Water pressure:	Duration of water spraying test on the wrap surface per m <sup>2</sup> :	Minimum duration of the test:	Distance between the nozzle and the wrap surface:
A moisture indicator paper sheet has been interposed between the lens and the clamping base	Nozzle Ø 6.3 millimeters	12.5 l/min ± 5%	30 kPa @ distance of 3m	1 min	3 min	2.5 Meters

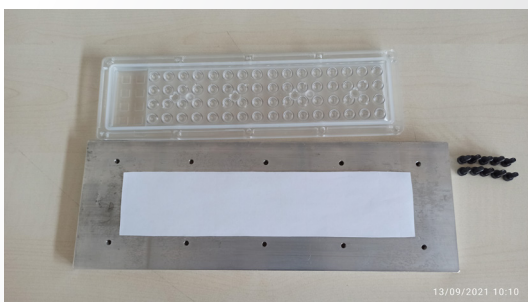
As shown in the photo, the test paper sheet is completely dry after disassembling the system.

**The test paper sheet is dry.**

The product has passed the Khatod test.

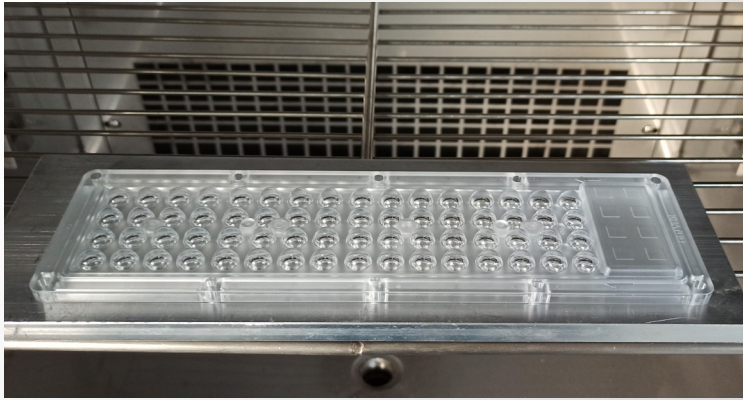
Before starting the tests, a visual inspection was performed in order to check the integrity of the part. The part resulted physically intact. The reference temperature of the component under test is 120° C. The climate chamber work without umidity.

**Photo: the part in the climatic chamber.**

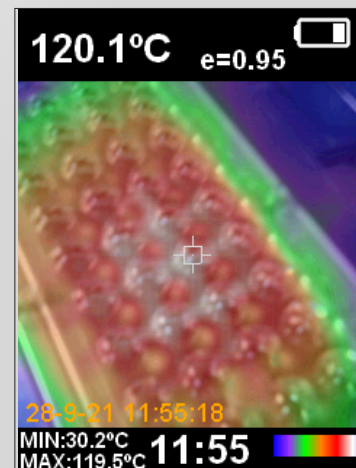
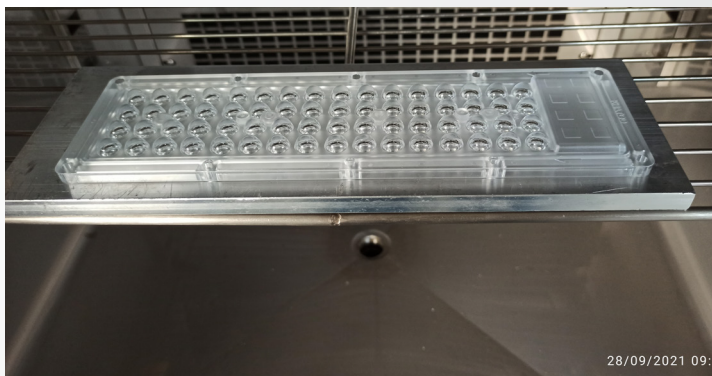
### Temperature detected on the part by IR thermal camera

**Photo: the part in the climatic chamber after testing.**

After testing, a final visual inspection was performed. The result was positive (view photo).

Based on the testing result, KFLEX64IP test specimens proved to overcome the thermal stress test up to 120°C, without any physical deterioration of the material.

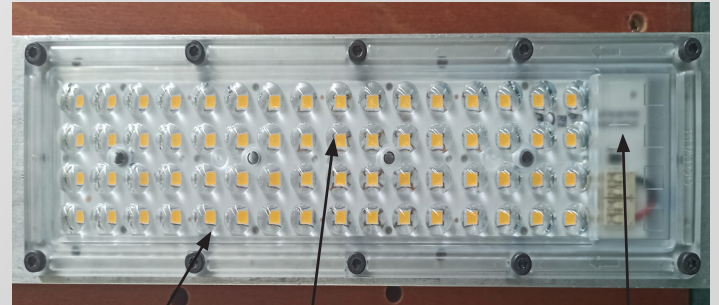
Before starting the tests, a visual inspection was performed in order to check the integrity of the components.

The components resulted physically intact.

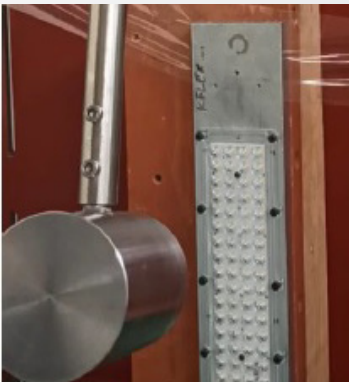
1<sup>st</sup> TEST

Tests were carried out on the part under test according to IK10 (1 Joule)

- Impact energy: 10 Joules
- Impacting element: 5000 grams
- Distance between impacting element and the part under test: 20 cm
- Number of impacts: 5

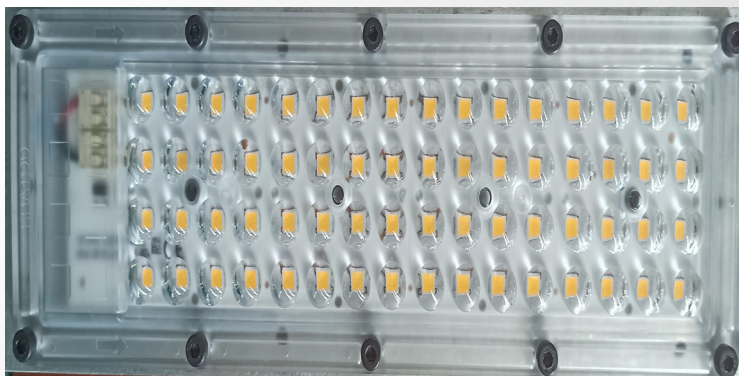
After testing, a final visual inspection was performed. The result was positive (view photo).
