Thermal shock resistance level with mechanical constraints

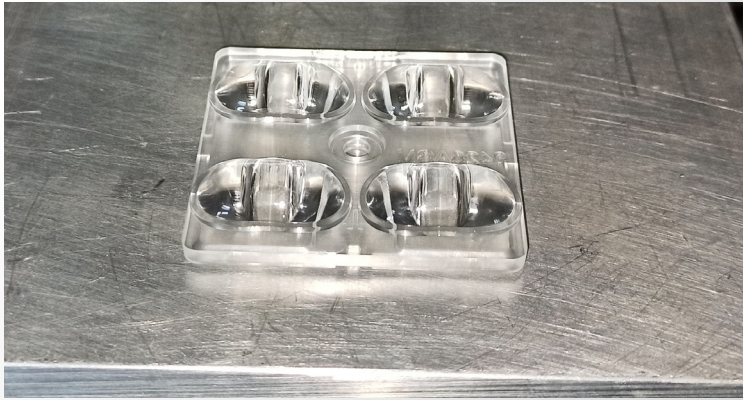
Before starting the tests, a visual inspection was performed in order to check the integrity of the part. The part resulted physically intact. The reference temperature of the component under test is 90° C. The climate chamber work without umidity.

Photo: the part in the climatic chamber.

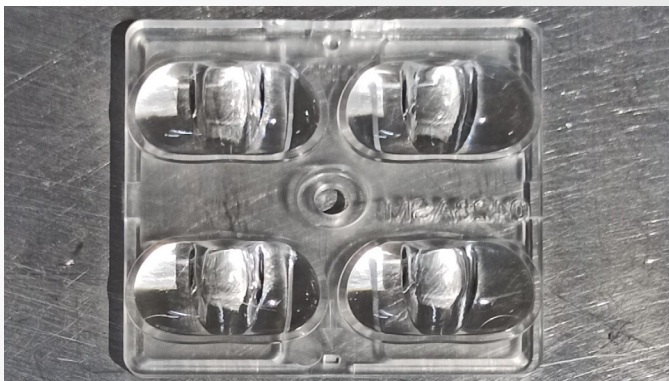
Photo: the part in the climatic chamber after testing.

After testing, a final visual inspection was performed. The result was positive (view photo).

Based on the testing result, KNAC04xxXSM test specimens proved to overcome the thermal stress test up to 90°C, without any physical deterioration of the material.
