## Thermal shock resistance level with mechanical constraints

## Determination of mechanical impact resistance degree (IK tests)

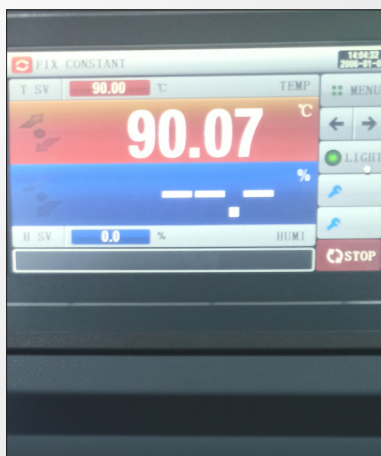
### Temperature set in the climatic chamber

Before starting the tests, a visual inspection was performed in order to check the integrity of the part. The part resulted physically intact. The thermal test was performed at a temperature of 90°C, using the climatic chamber LTH 225°.

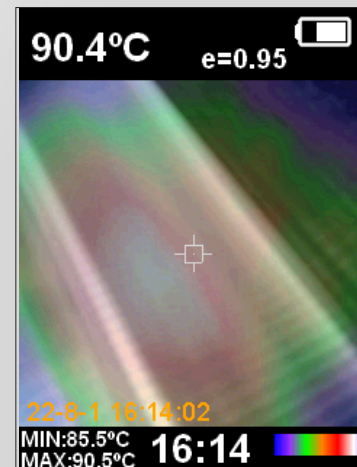
### Temperature detected on the part by IR thermal camera

The executed tests show that SAGITTARIO, moulded in PMMA 7N, passed the thermal stress tests without any physical deterioration of the material, up to a temperature of 90°C. At the end of the test the sample size is 259.00 mm.
